THE GREAT ALASKA EARTHQUAKE

Volume II

Illustrations and Maps

TECHNICAL REPORT NO. AFWL-TR-65-92, Vol II

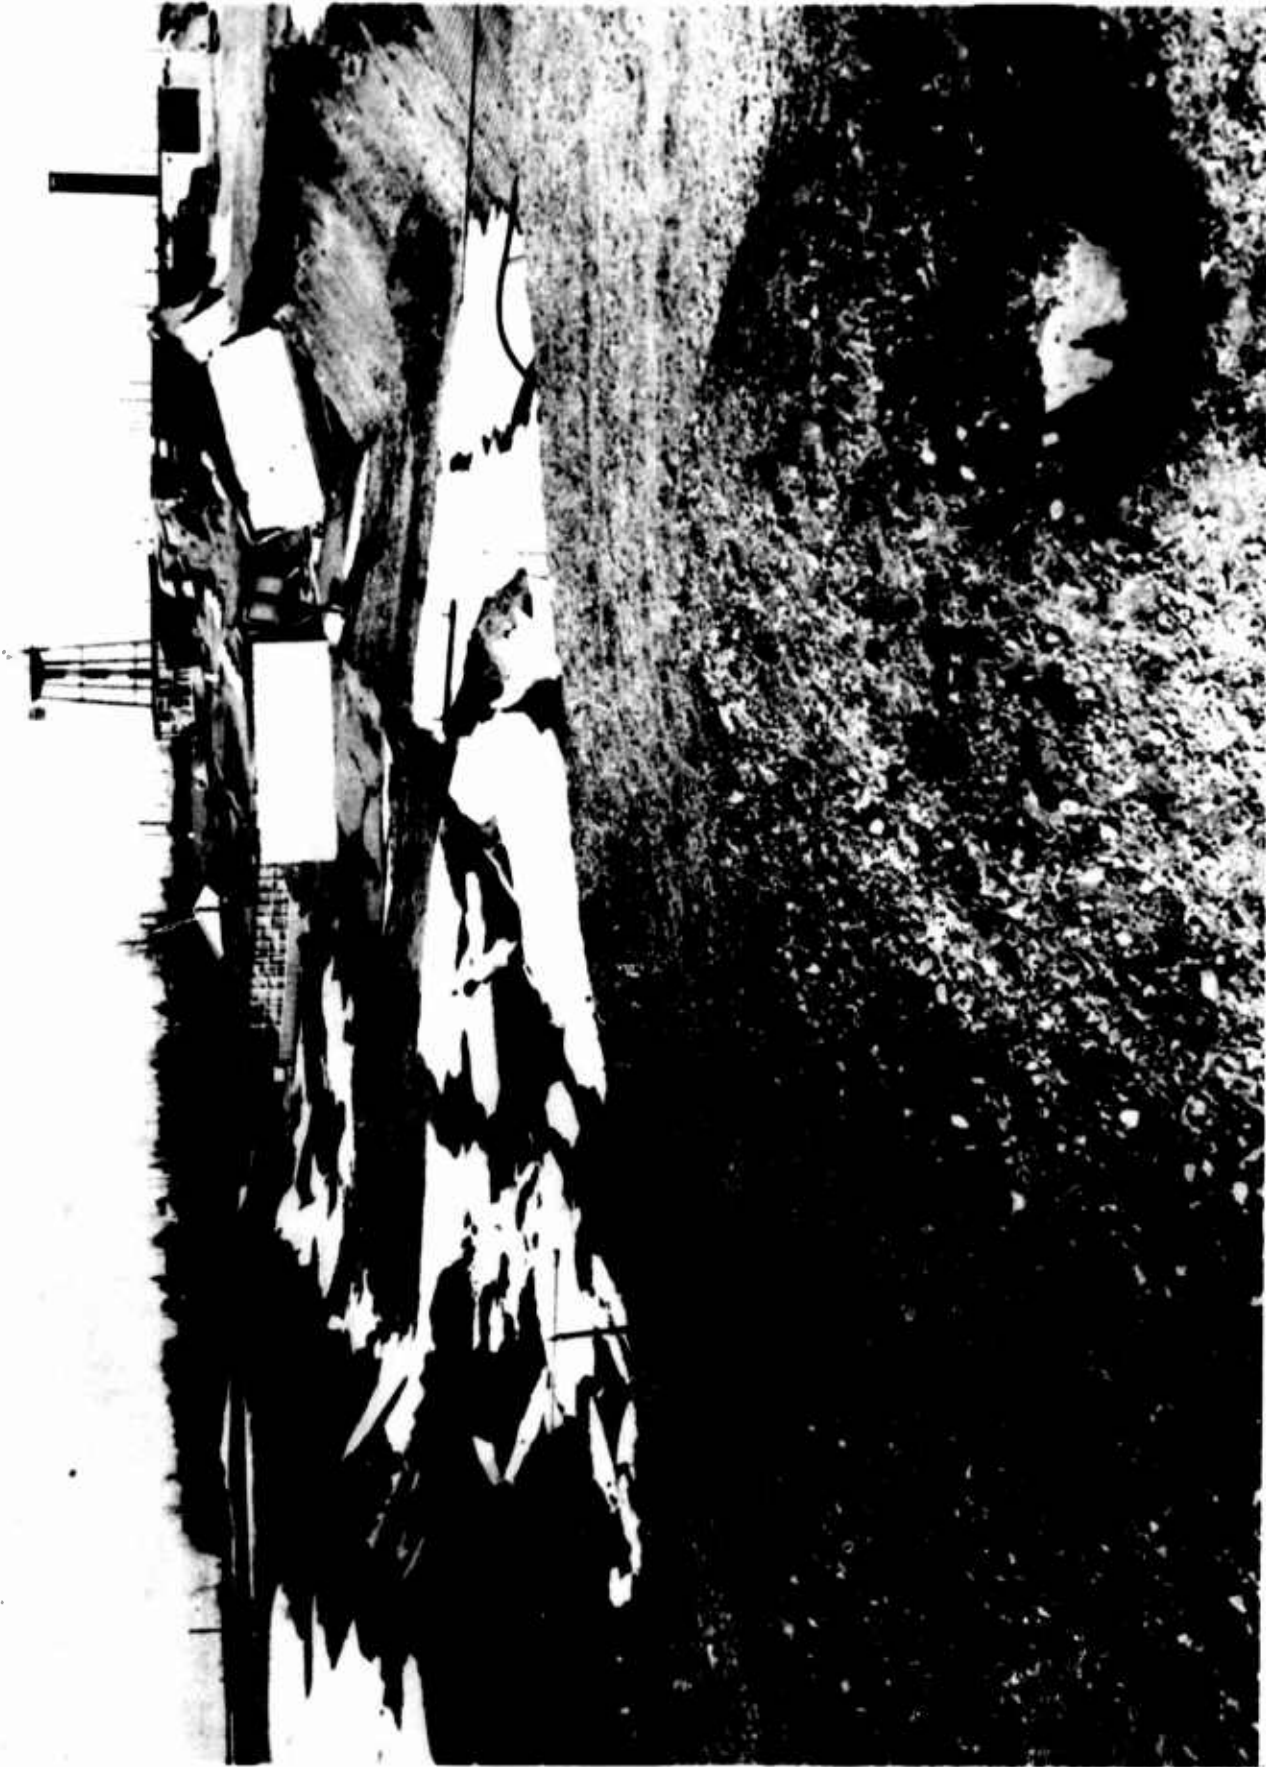
Figure 100. Government Hill Slide (The Government Hill school looking west)

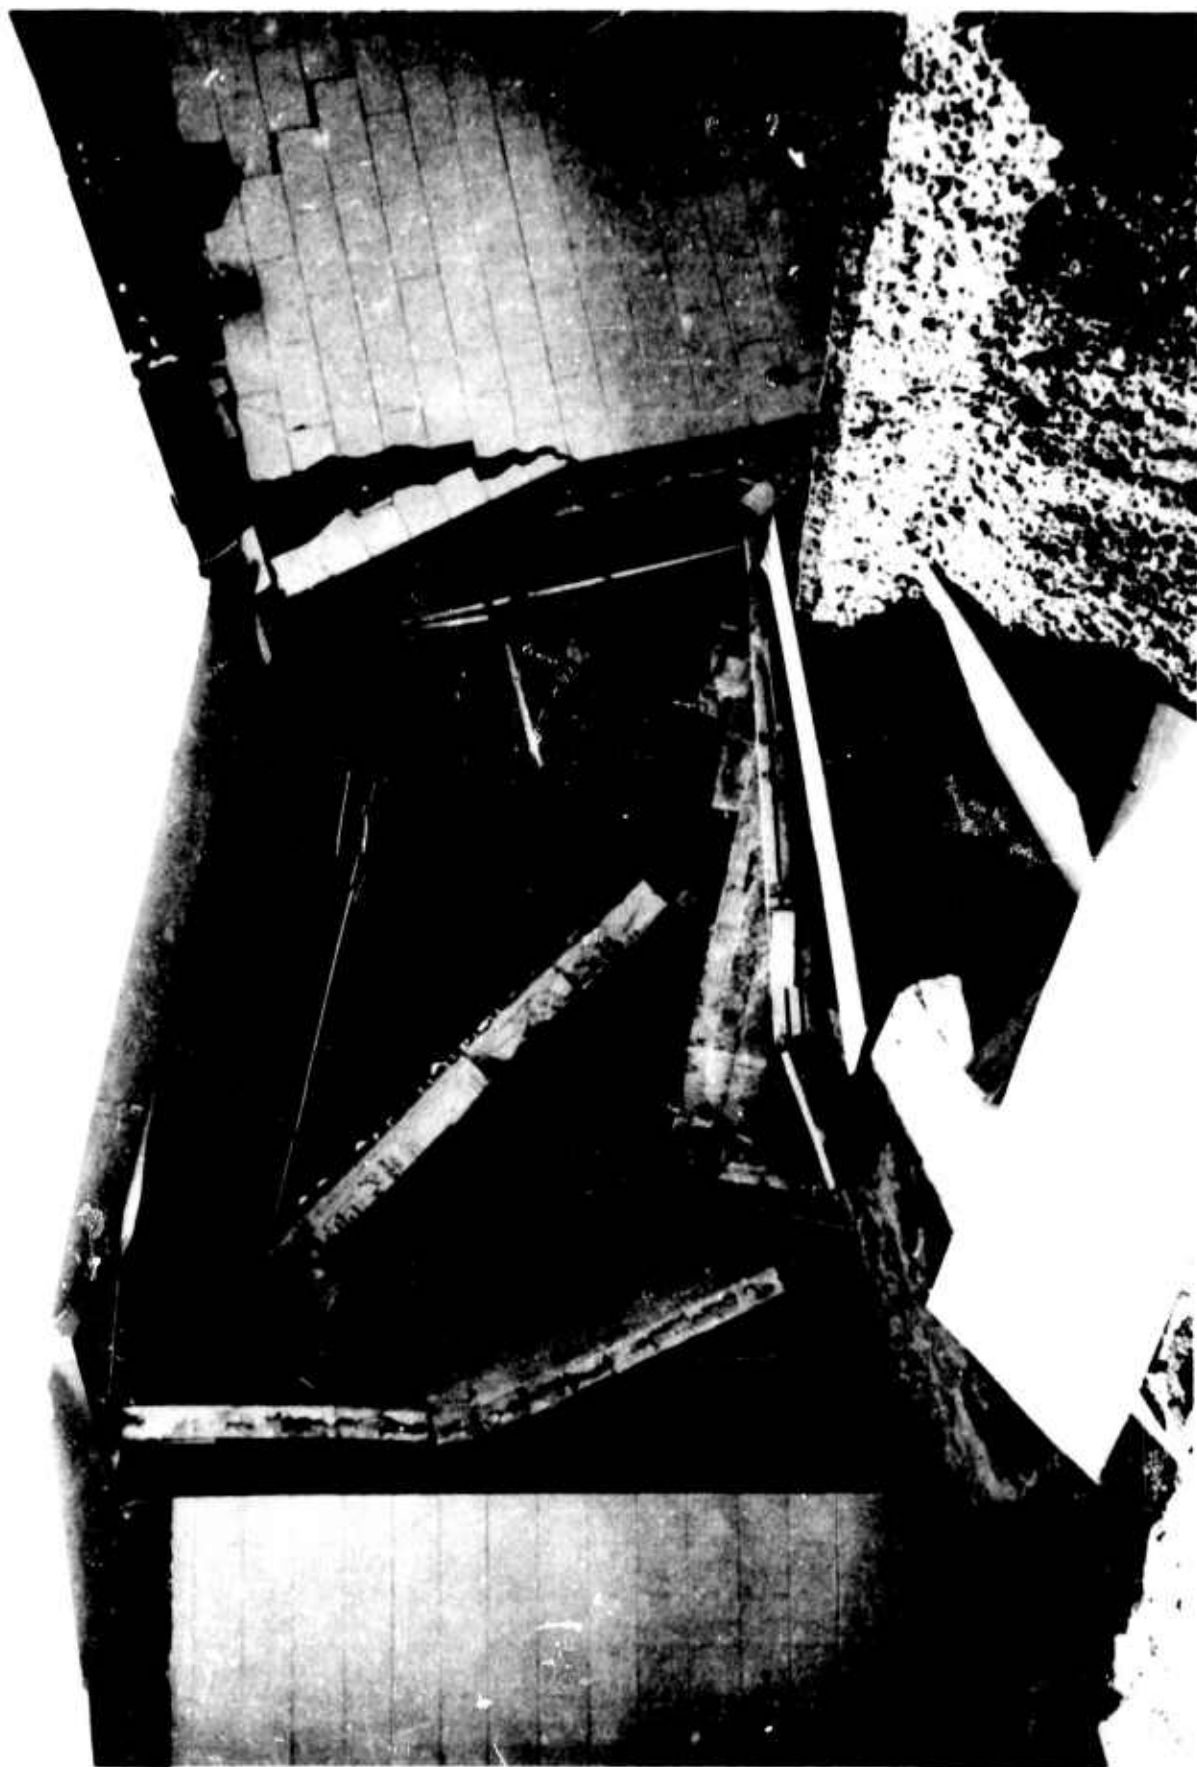
Figure 101. Government Hill Slide (Looking into the east-west corridor of the Government Hill school)

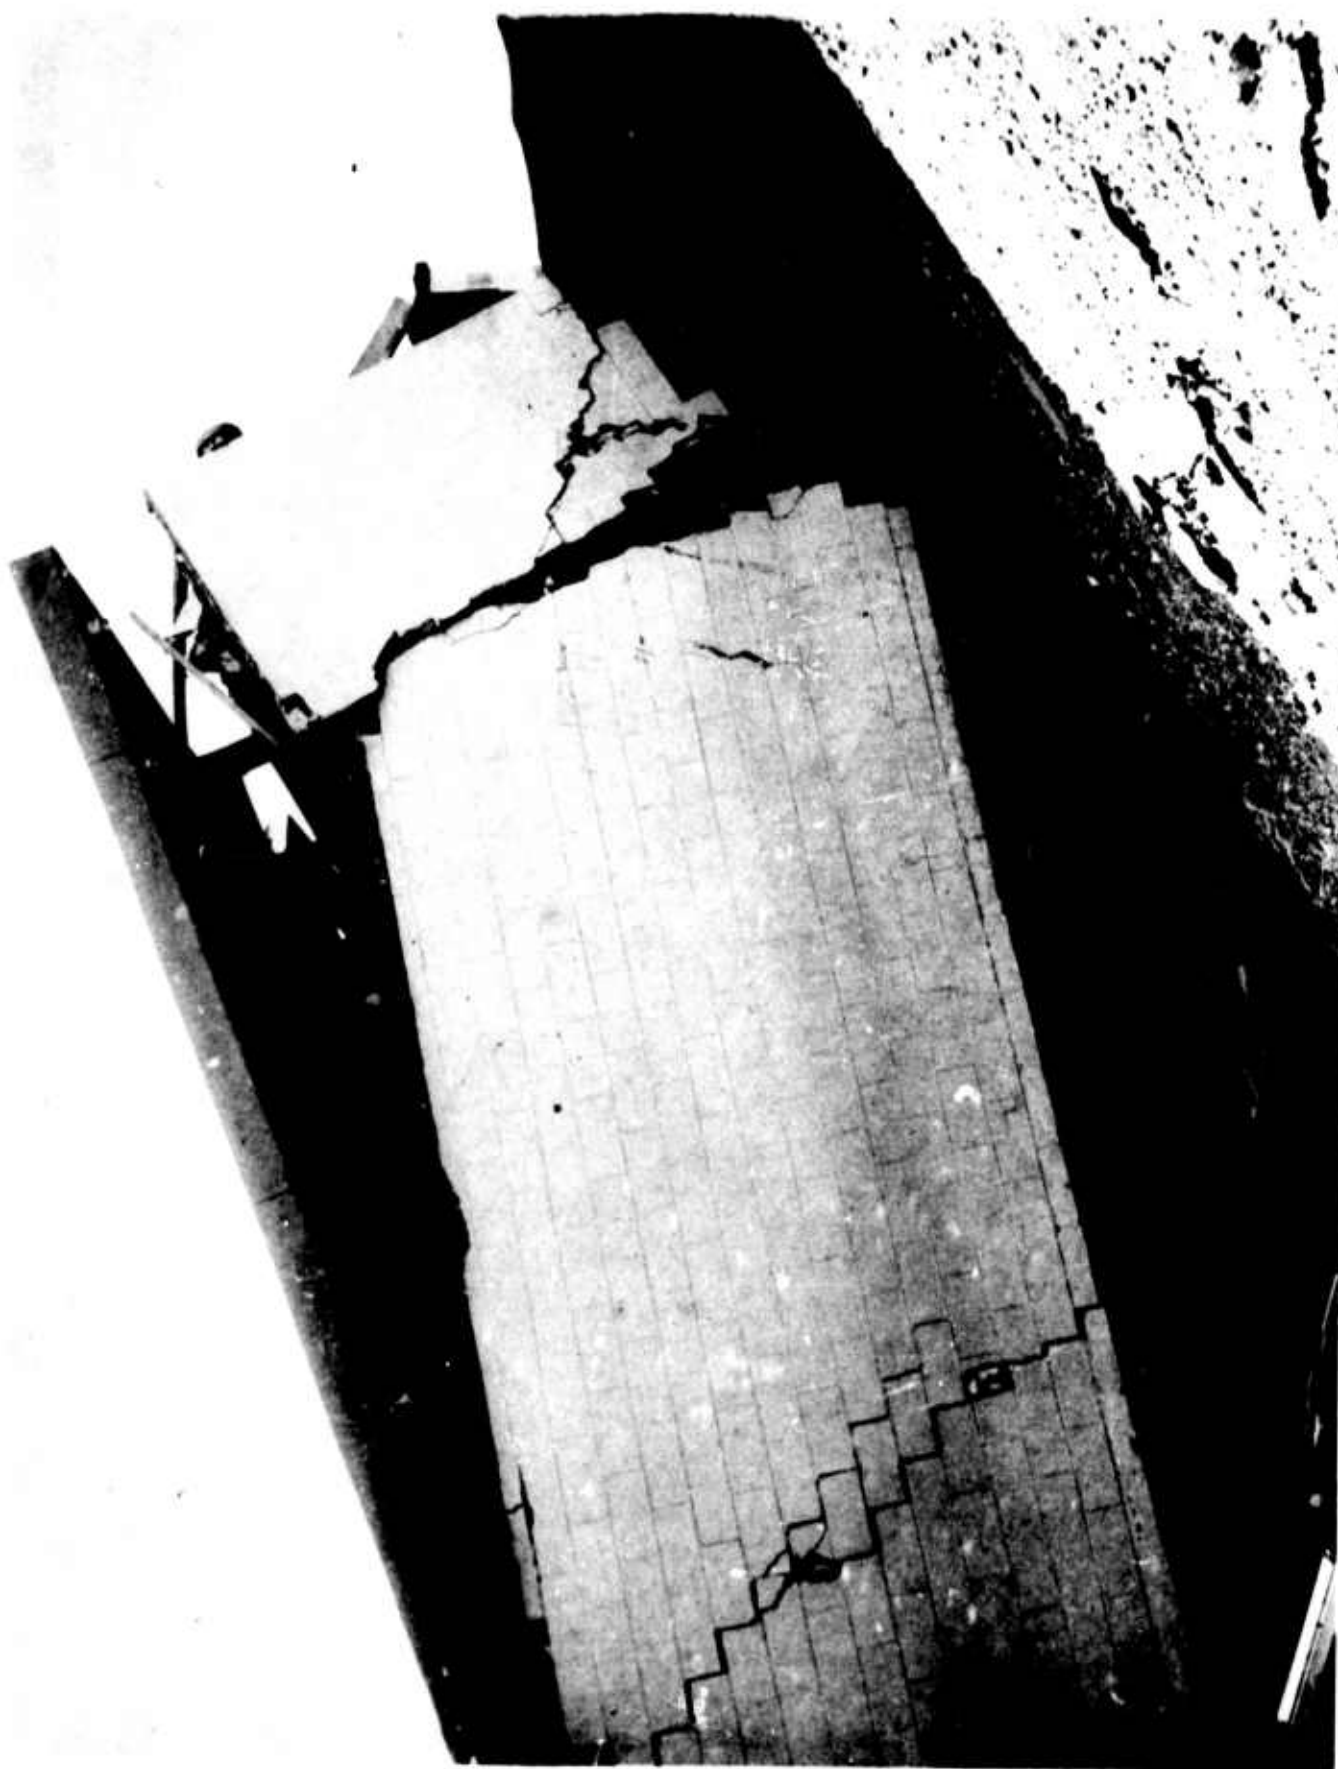
Figure 102. Government Hill Slide (Northeast corner of the east-west wing of the Government Hill School)

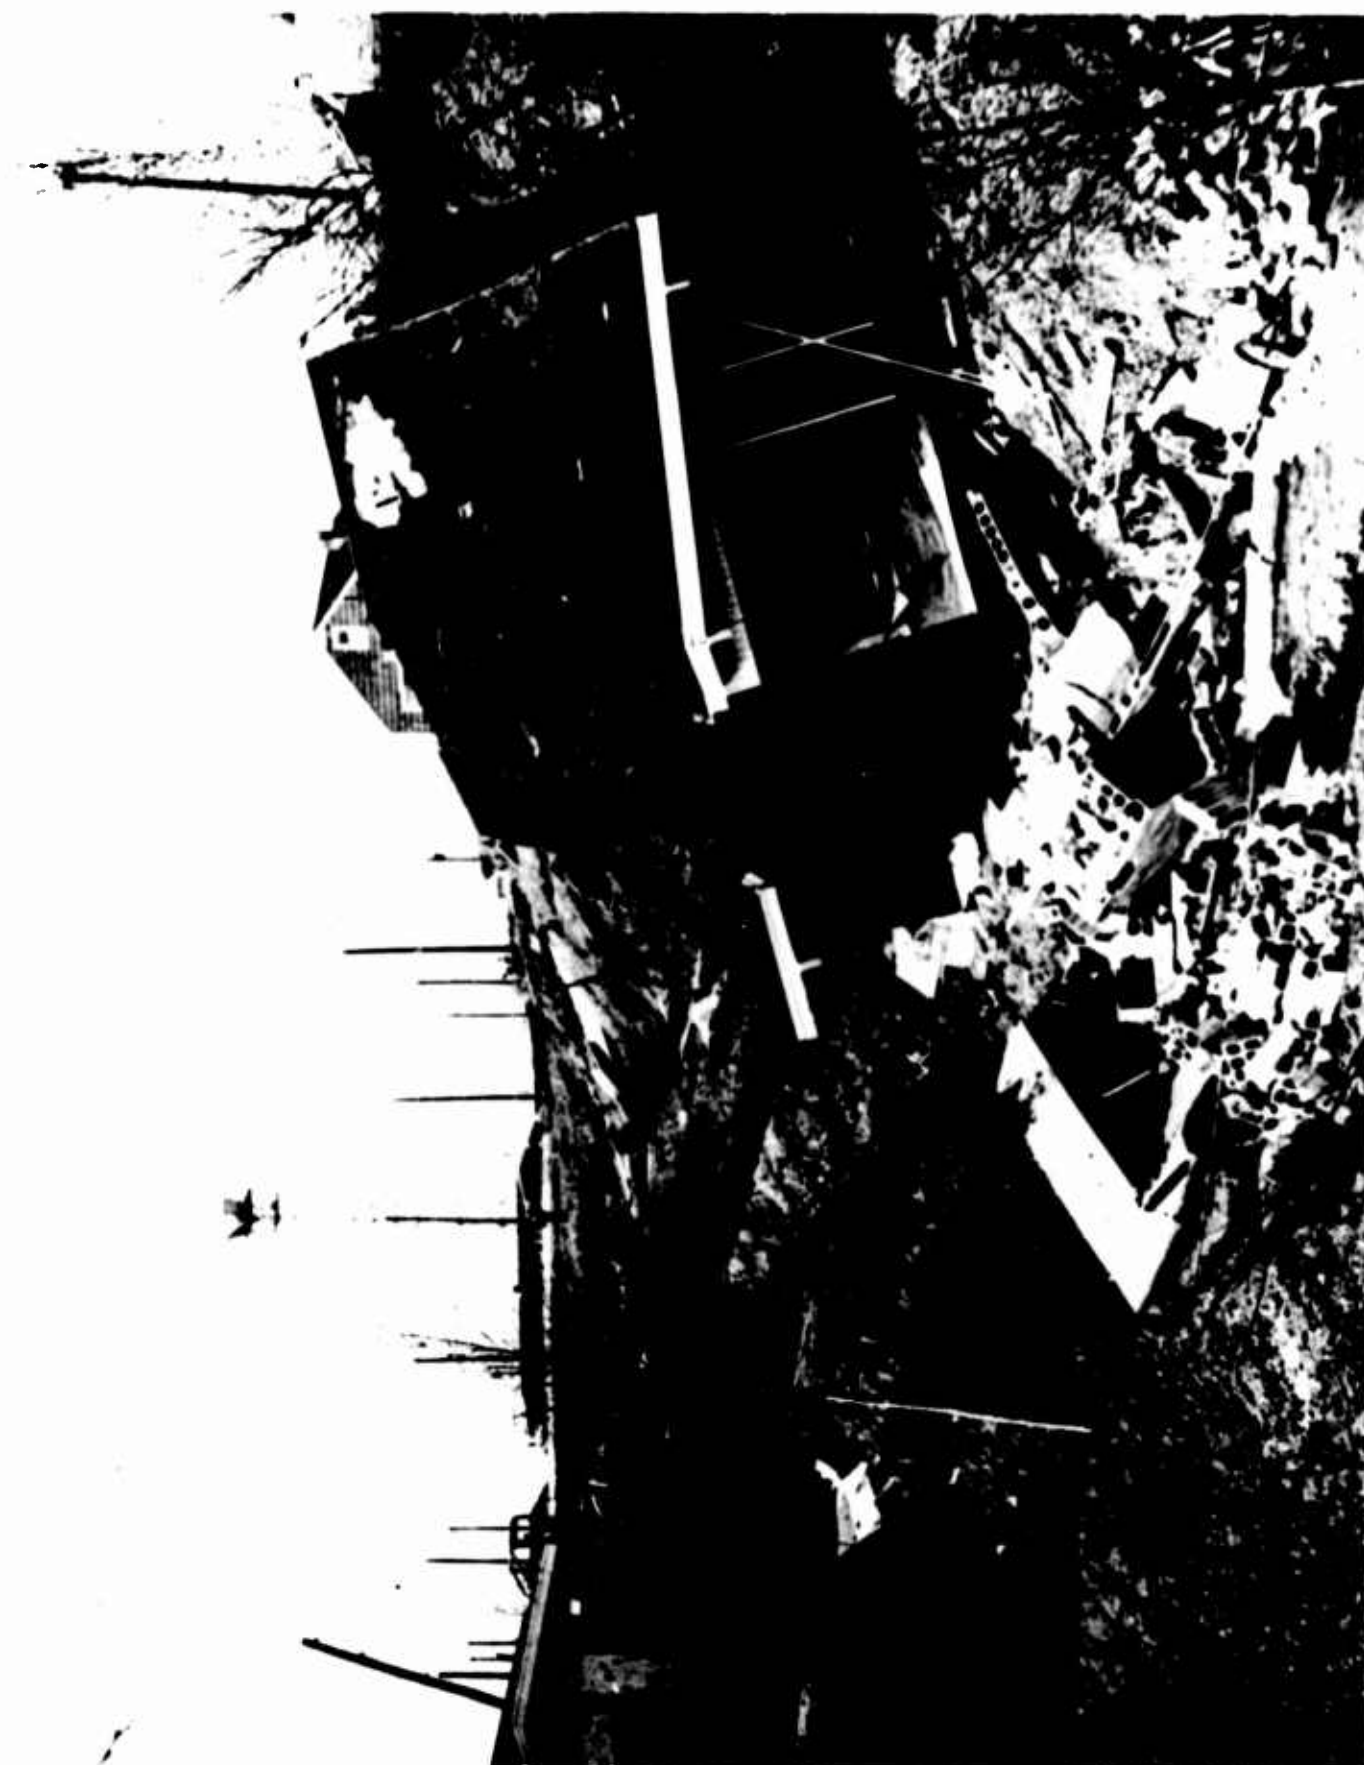
Figure 105. Government Hill Slide (Residence)

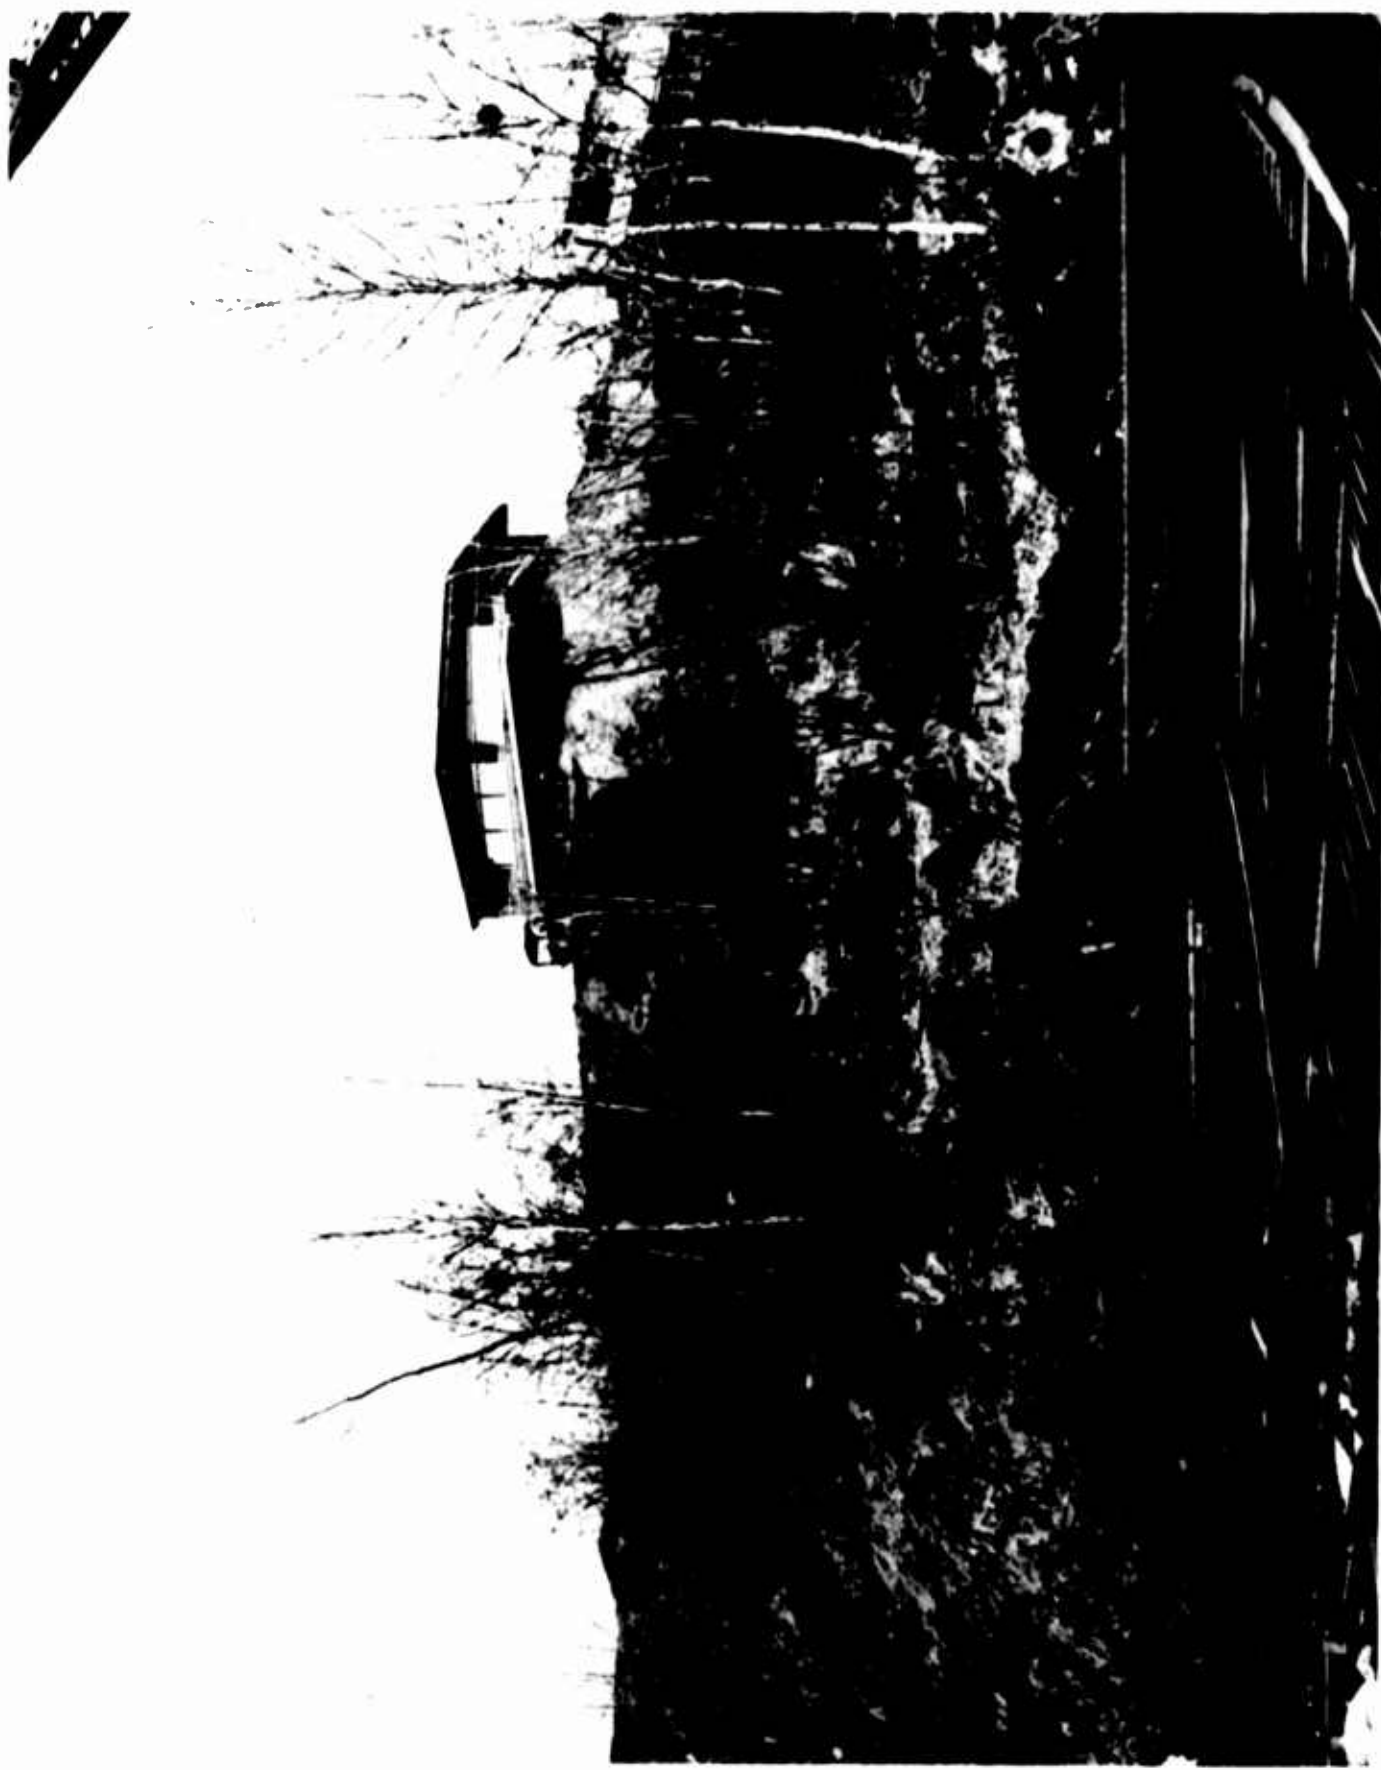
Figure 107. Government Hill Slide (View of the west residence from the toe of the slide)

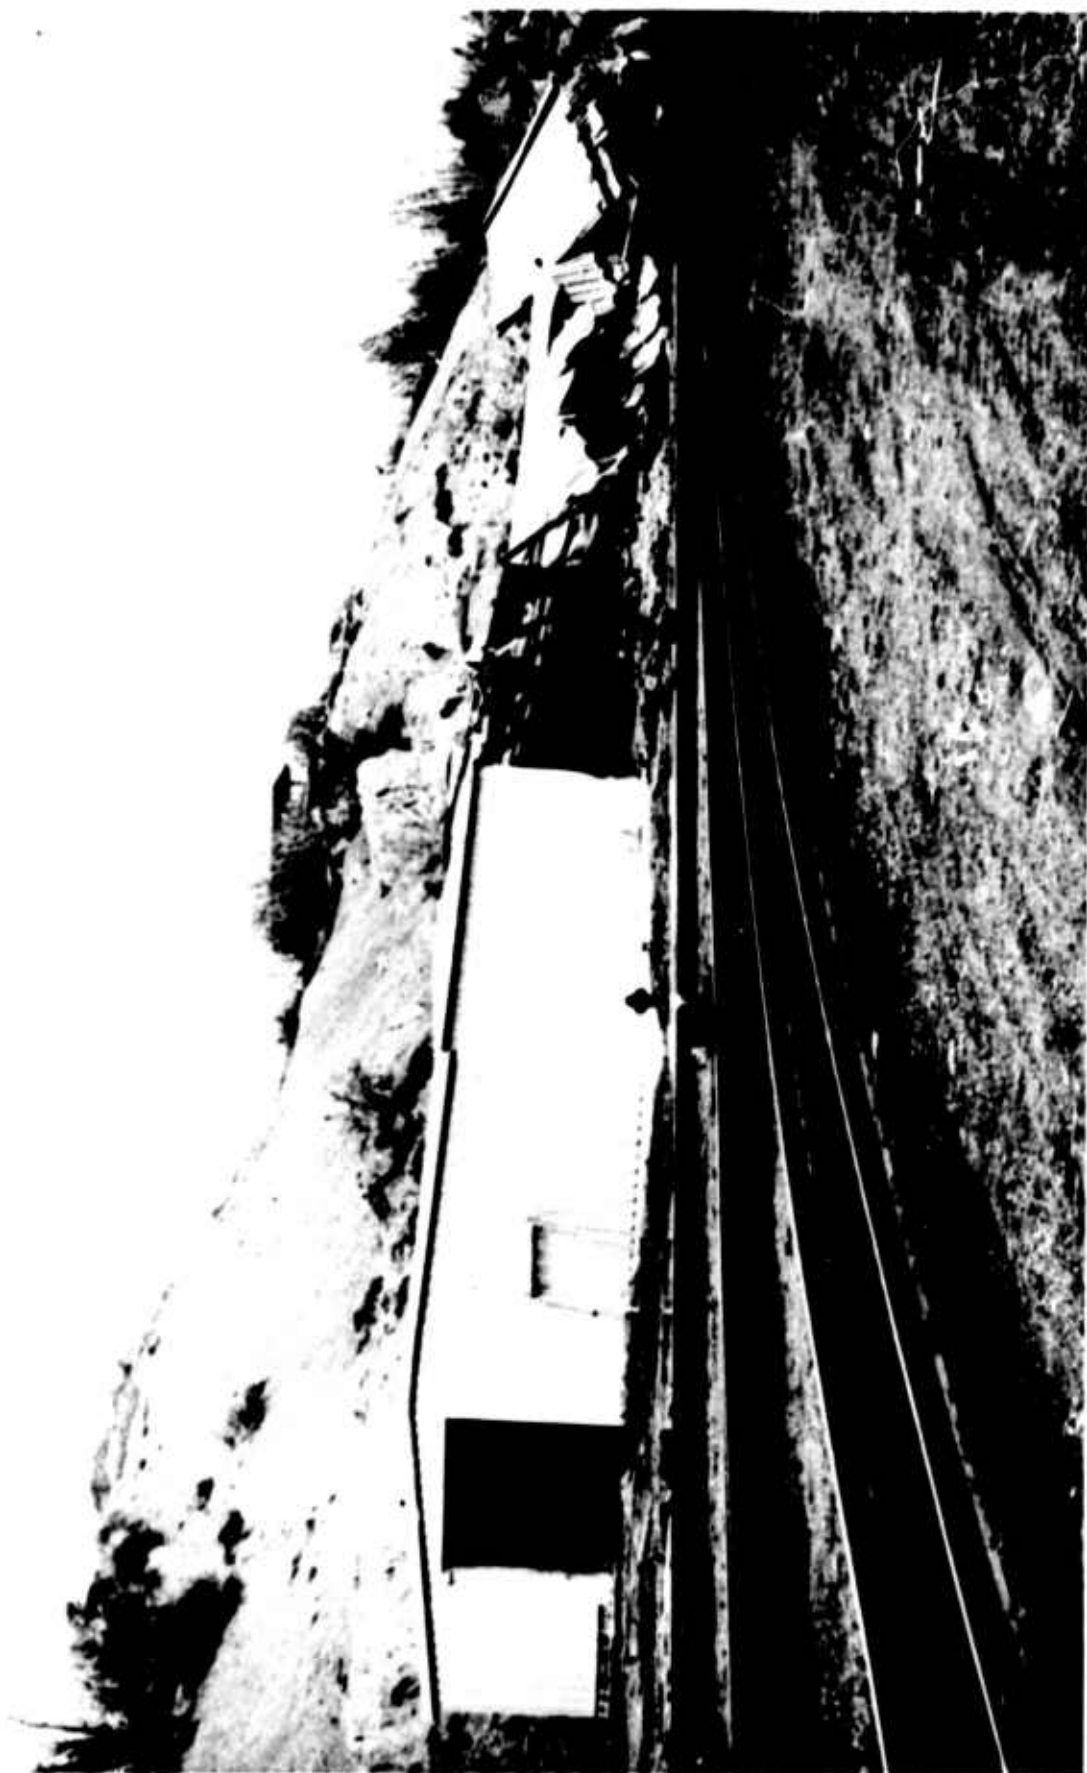
Figure 110. Government Hill Slide (Warehouse used by the Alaska Railroad as it appeared in late May 1964)

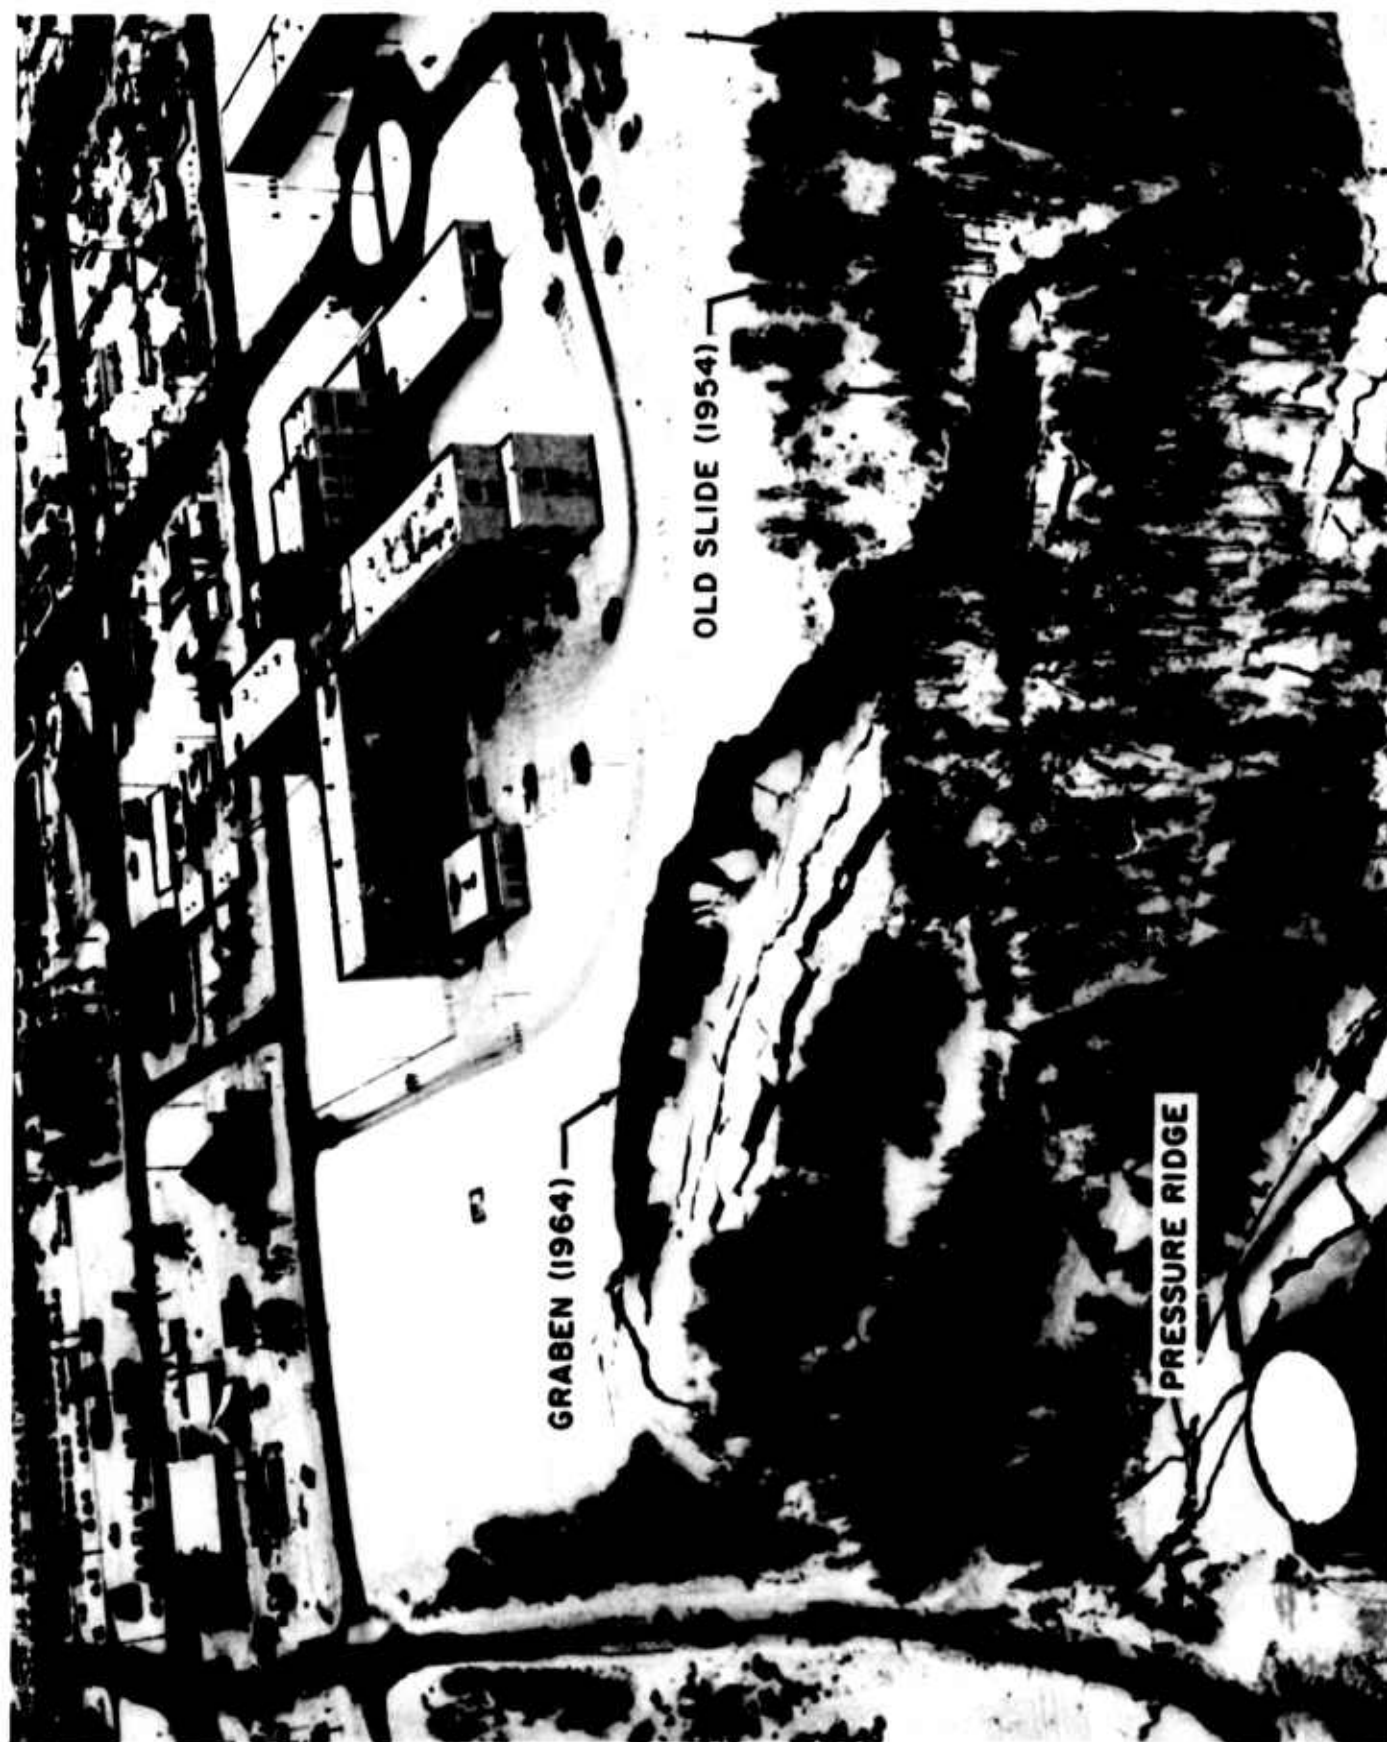
Figure 117. First Avenue Slide (Aerial view of a fuel storage tank destroyed by the slide)

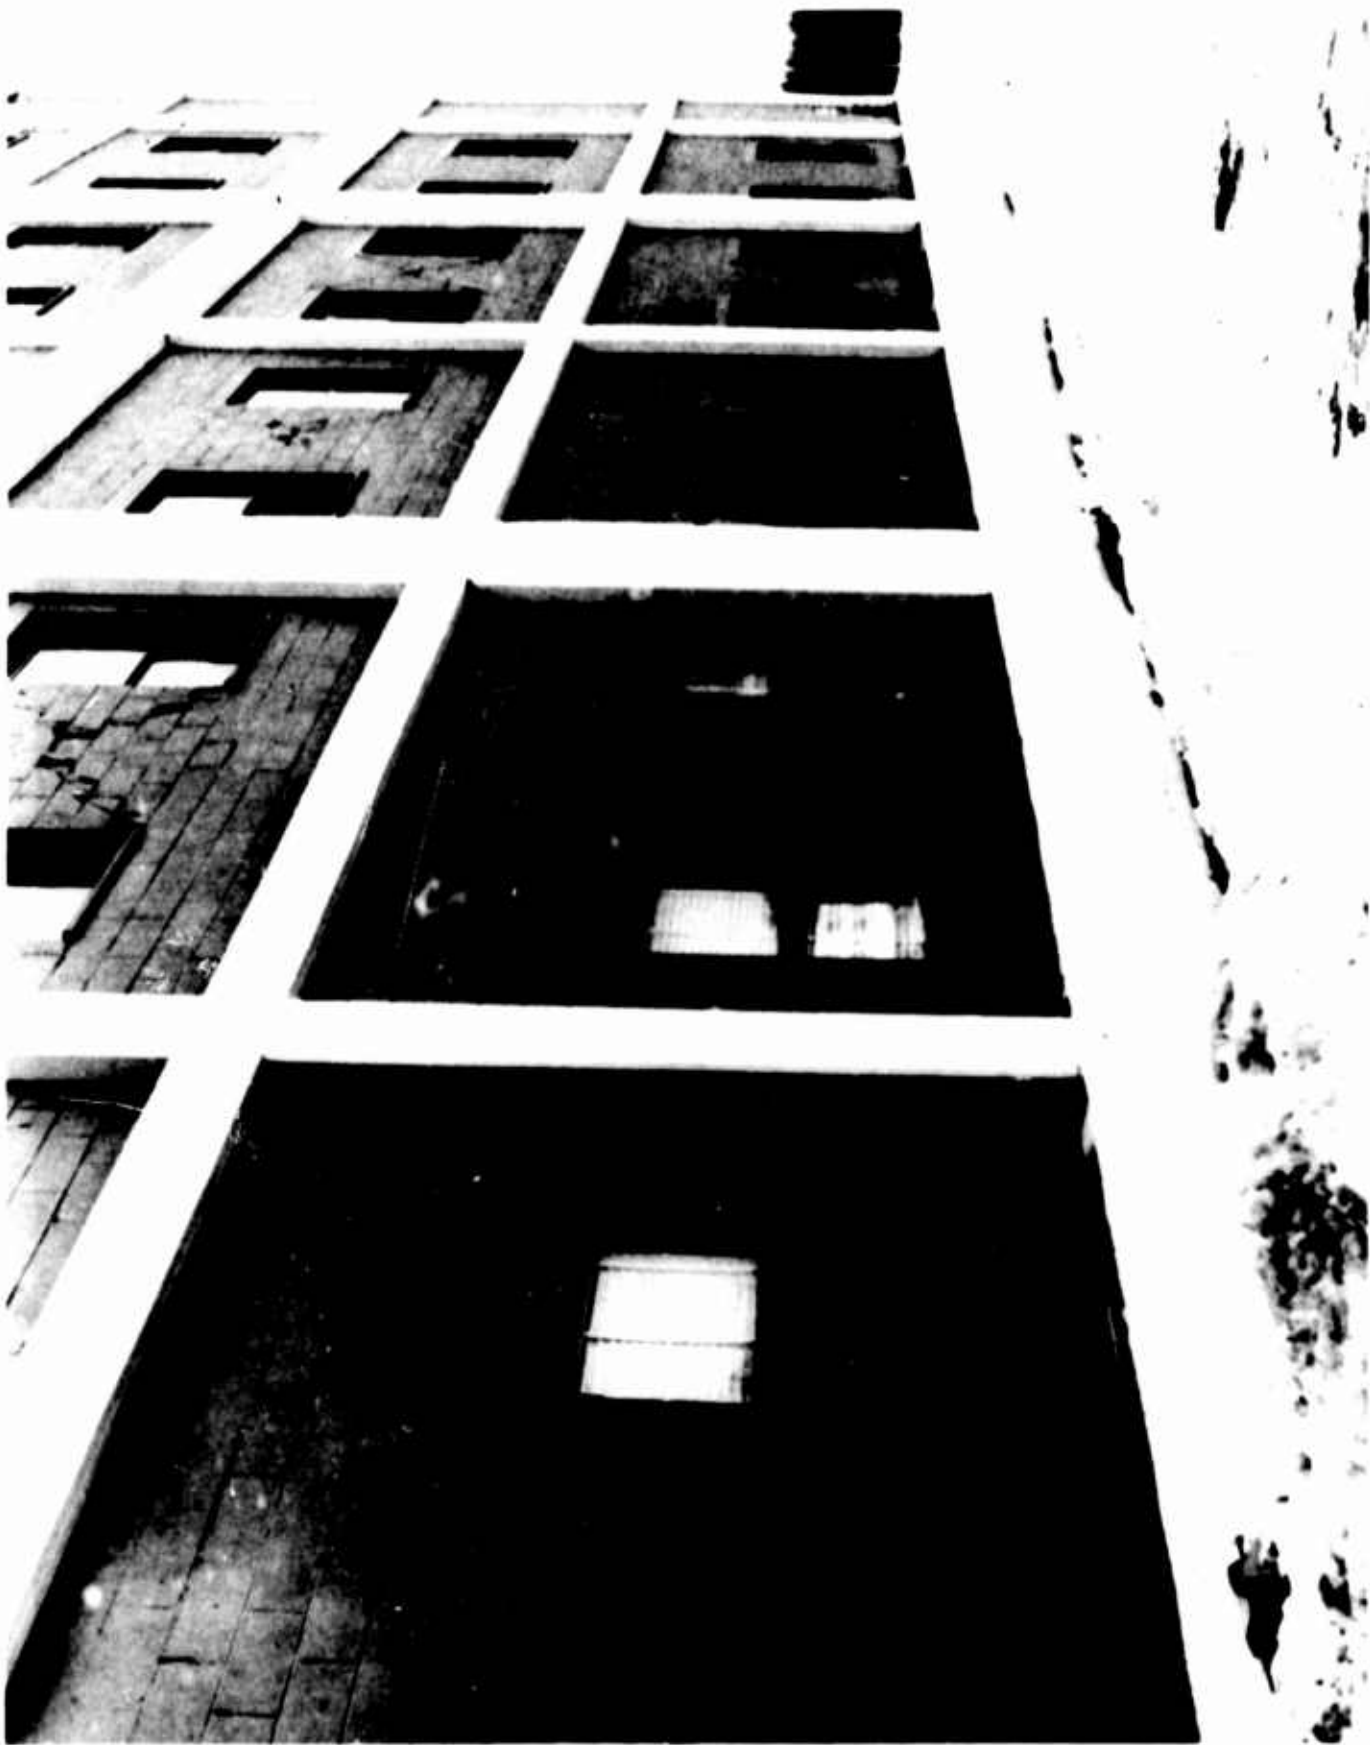
Figure 120. Elmendorf AFB Hospital (Diagonal tension cracks in masonry-filler walls)

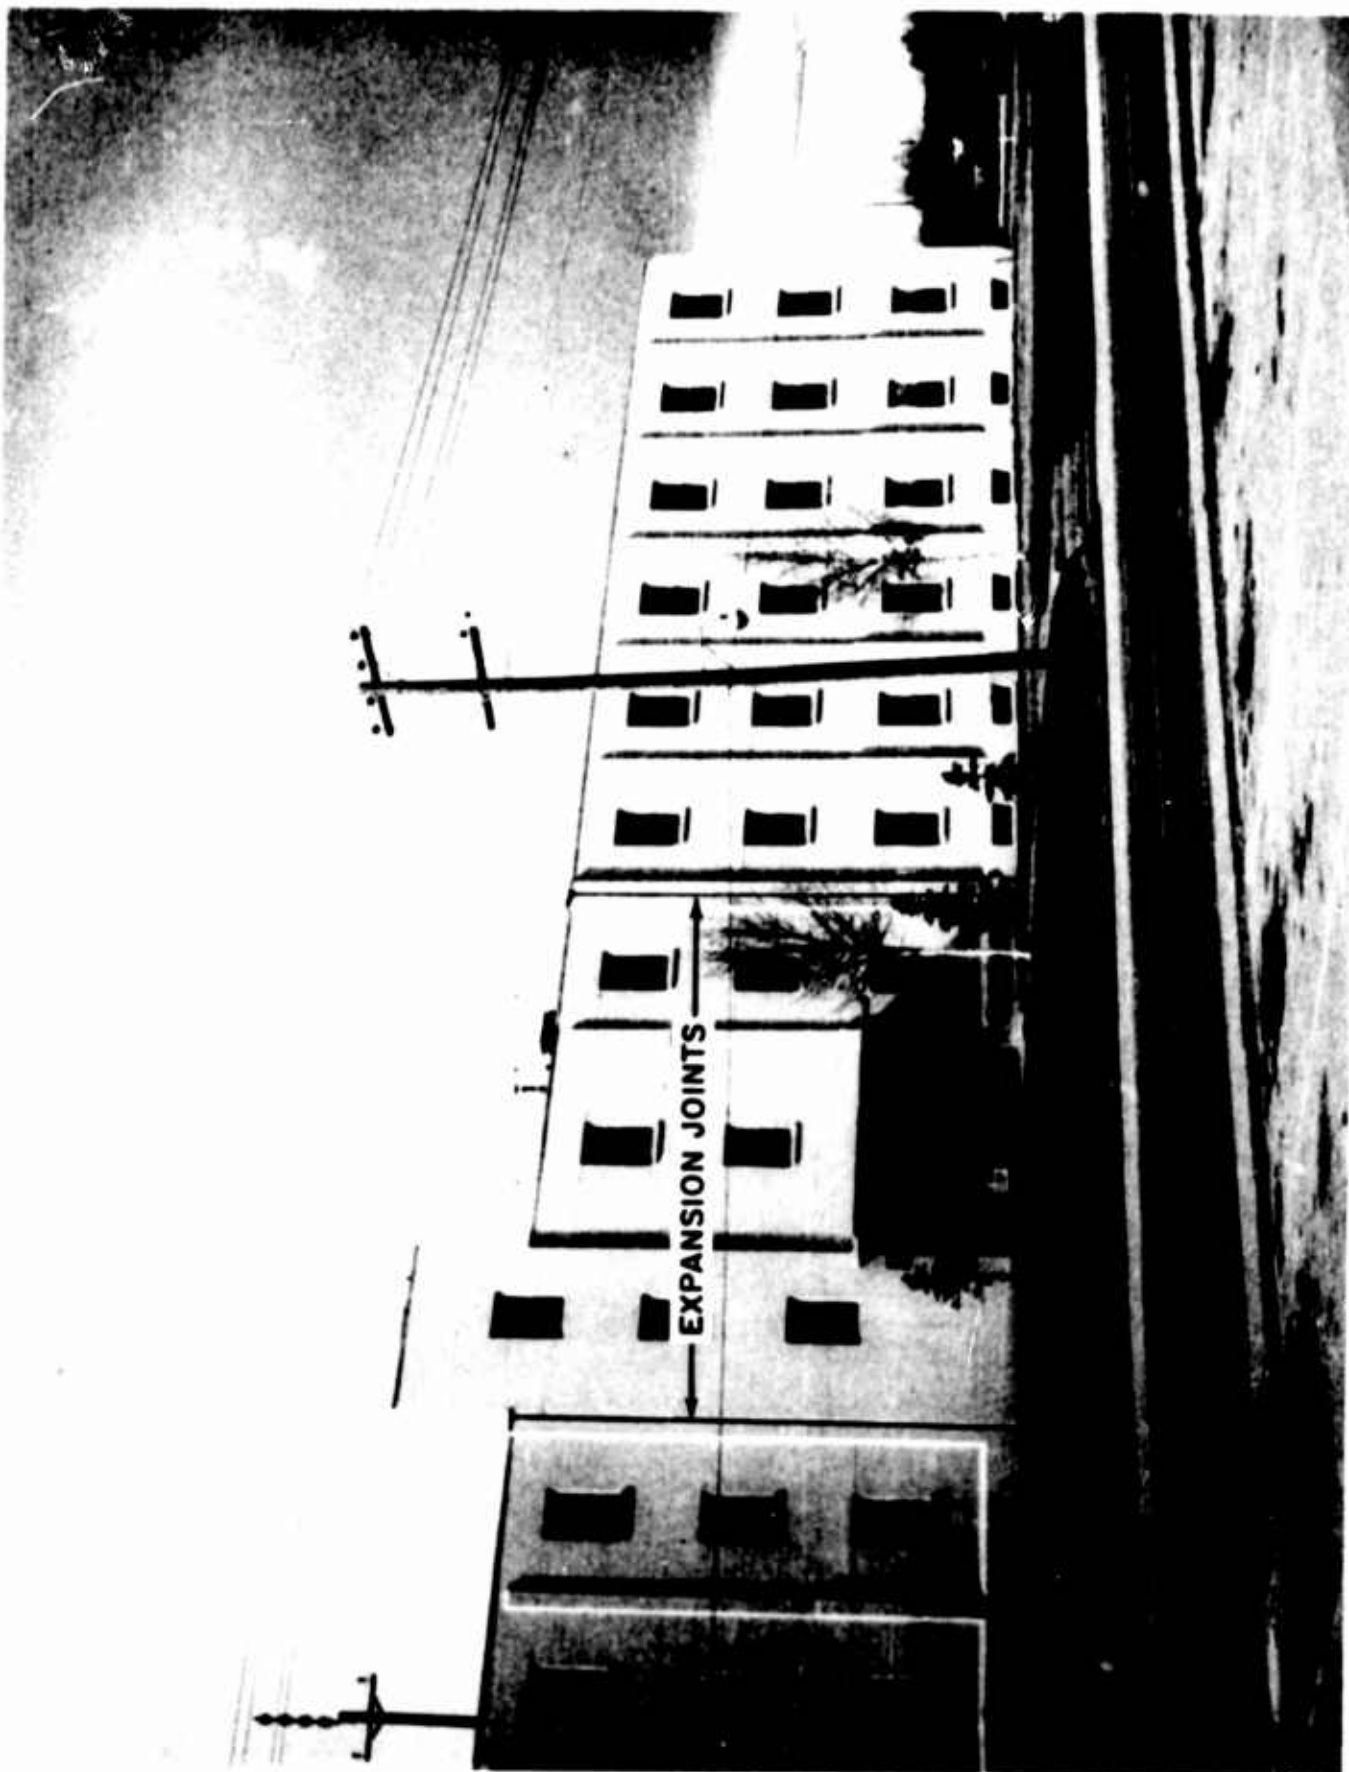
Figure 123. Elmendorf AFB 750-Man Barracks (East end of Building 31-270 showing expansion joints)

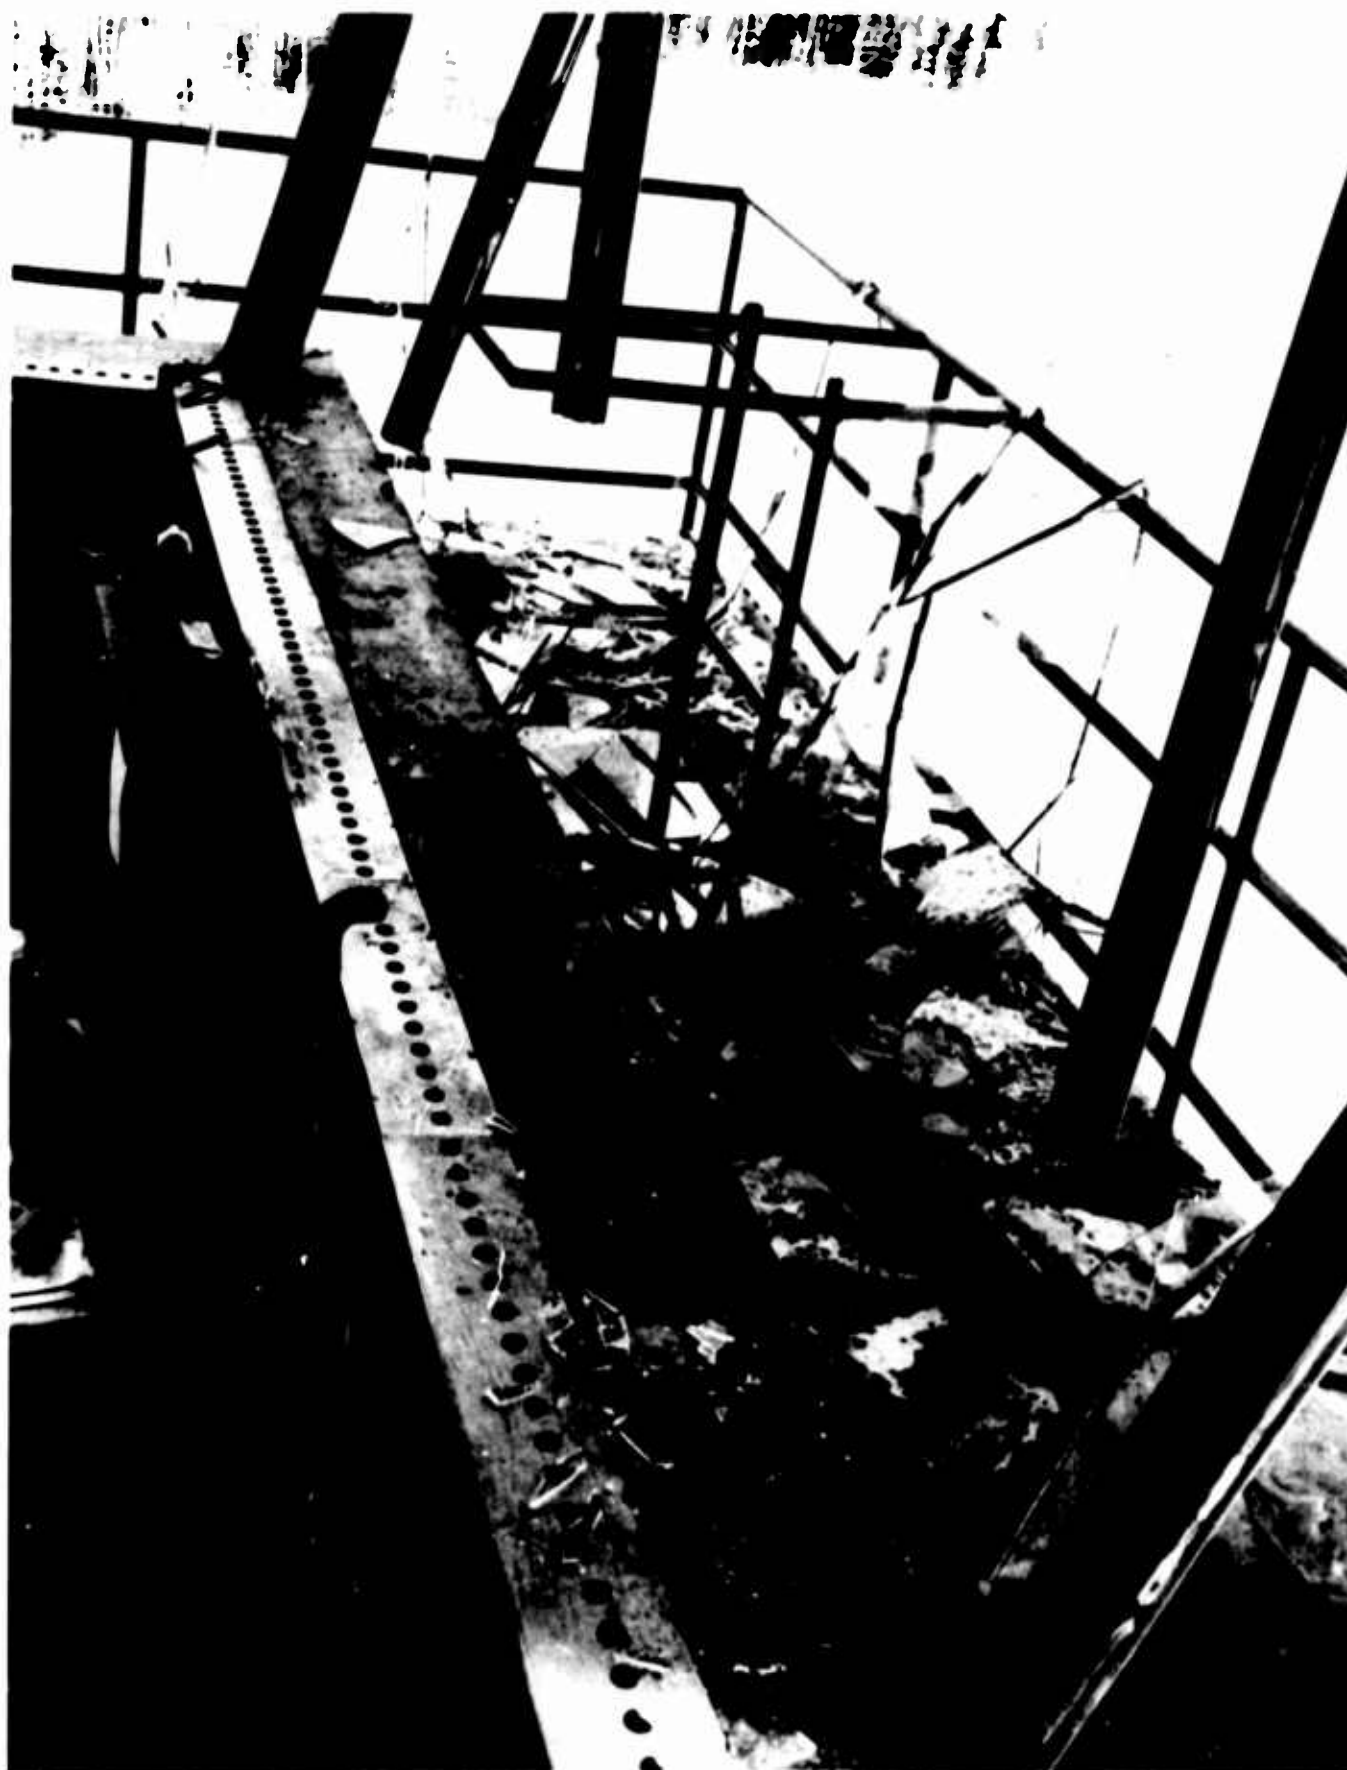
Figure 133. Elmendorf AFB Aircraft Control Tower
(Severely damaged observation cupola)
